**CLIENT:** **TAYLOR BROTHERS DOOR LOCK, LLC**  
11701 Union St.  
Mount Morris, MI  
48458

**Test Report No: T1385-1**

**SAMPLE ID:** Taylor Brothers Door Lock NightLock Lockdown hardware.

**TEST RESULTS:** The Taylor Brothers Door Lock NightLock Lockdown hardware met the requirements of the test standards for a 20 minute and 90 minute fire-resistance rating with hose stream.

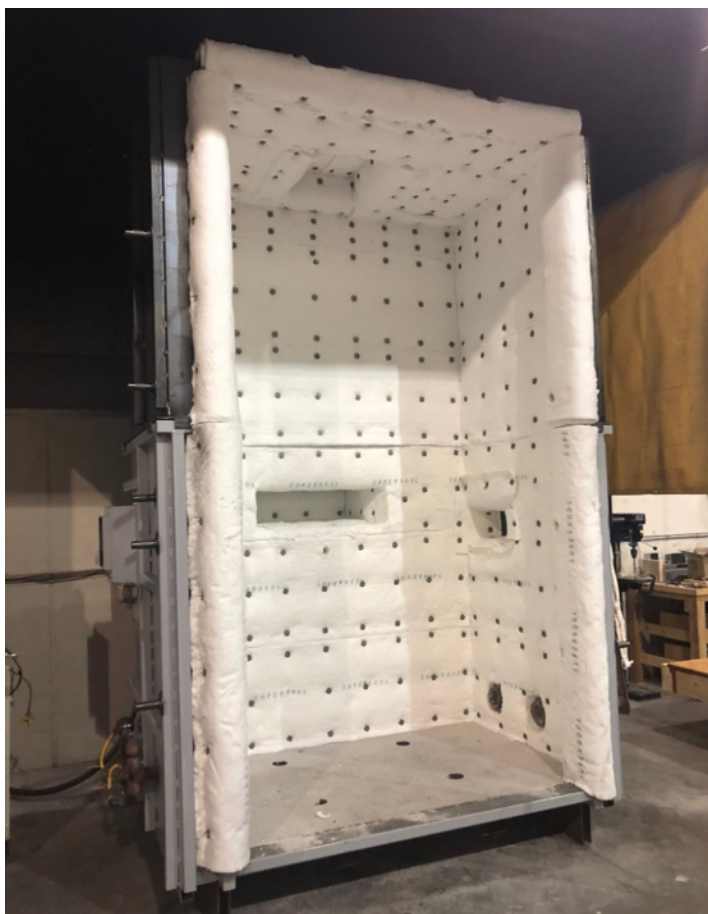
**Figure 1: Test Furnace**

The furnace used in the test is a mid-scale fire burning apparatus with interior dimensions of 10 ft. 4 in. (1.78 m) in height, 5 ft. 5 in. (1.65 m) in width, and 52 in. (1.32 m) in depth.

Temperatures within the furnace were monitored using eight thermocouples. The temperatures are controlled by adjusting fuel to the furnace burners to conform to the time/temperature curve specified by the test standards. Temperature measurements are recorded by a Keithley 2750 data acquisition unit (ID# DMM1) which passes the readings to a computer for graphical display and storage.

The door and frame assemblies were mounted in a vertical steel test frame. The test frame is then rolled up to the furnace and secured by chain and straps to the furnace opening.

Two pressure taps are installed along the longitudinal center line of the test assembly. The pressure taps are each attached and monitored by Setra model 264 pressure transducers (ID# Pressure T3 and Pressure T4). The furnace pressure is controlled by adjusting a damper in the furnace exhaust stack.

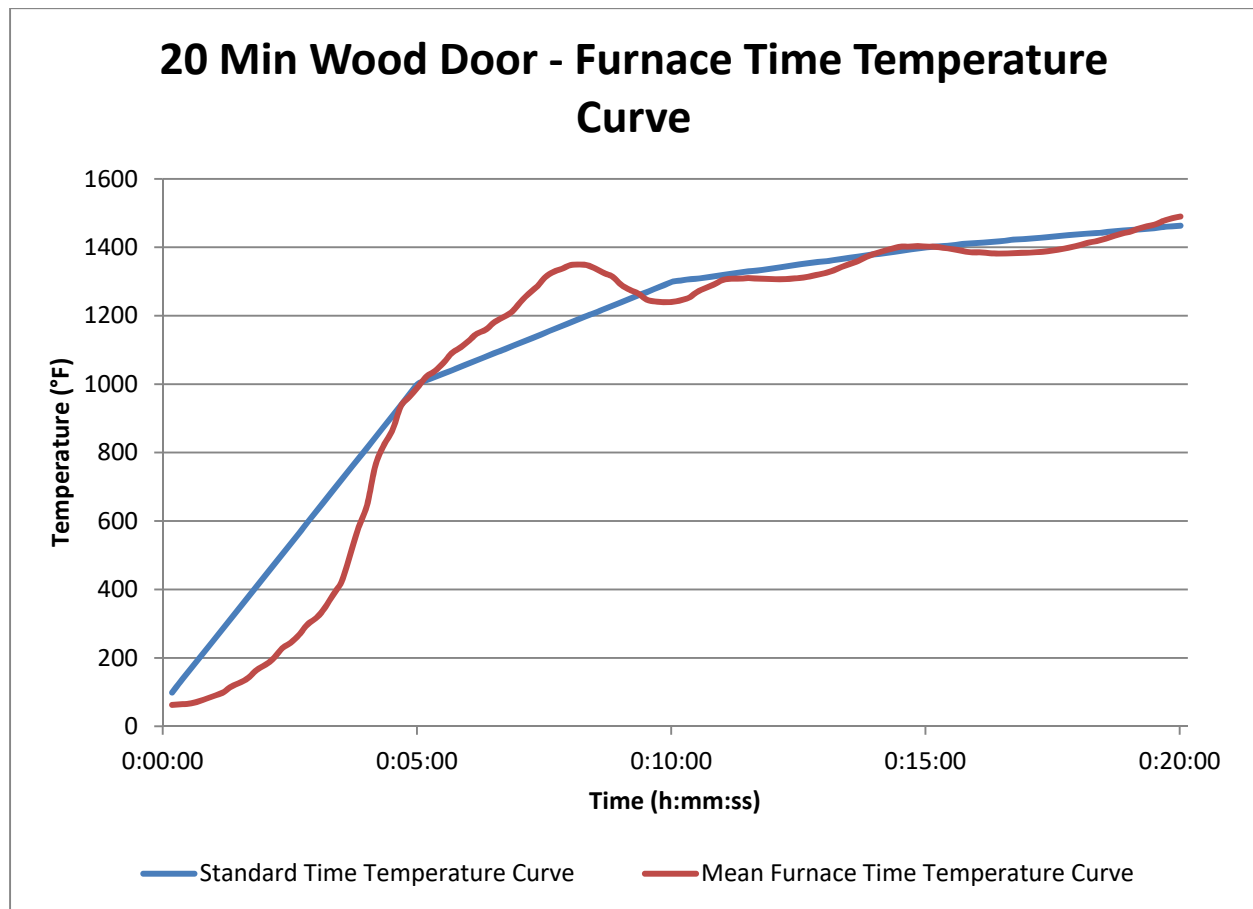
**Figure 2: Furnace Time Temperature Curve.**

Prior to the fire endurance test the test assembly was fastened to the front of the furnace, and the burners were ignited. The fire endurance test was initiated after igniting the burners. The temperature inside the furnace was controlled to follow the time/temperature curve within the limits described in the test standards.

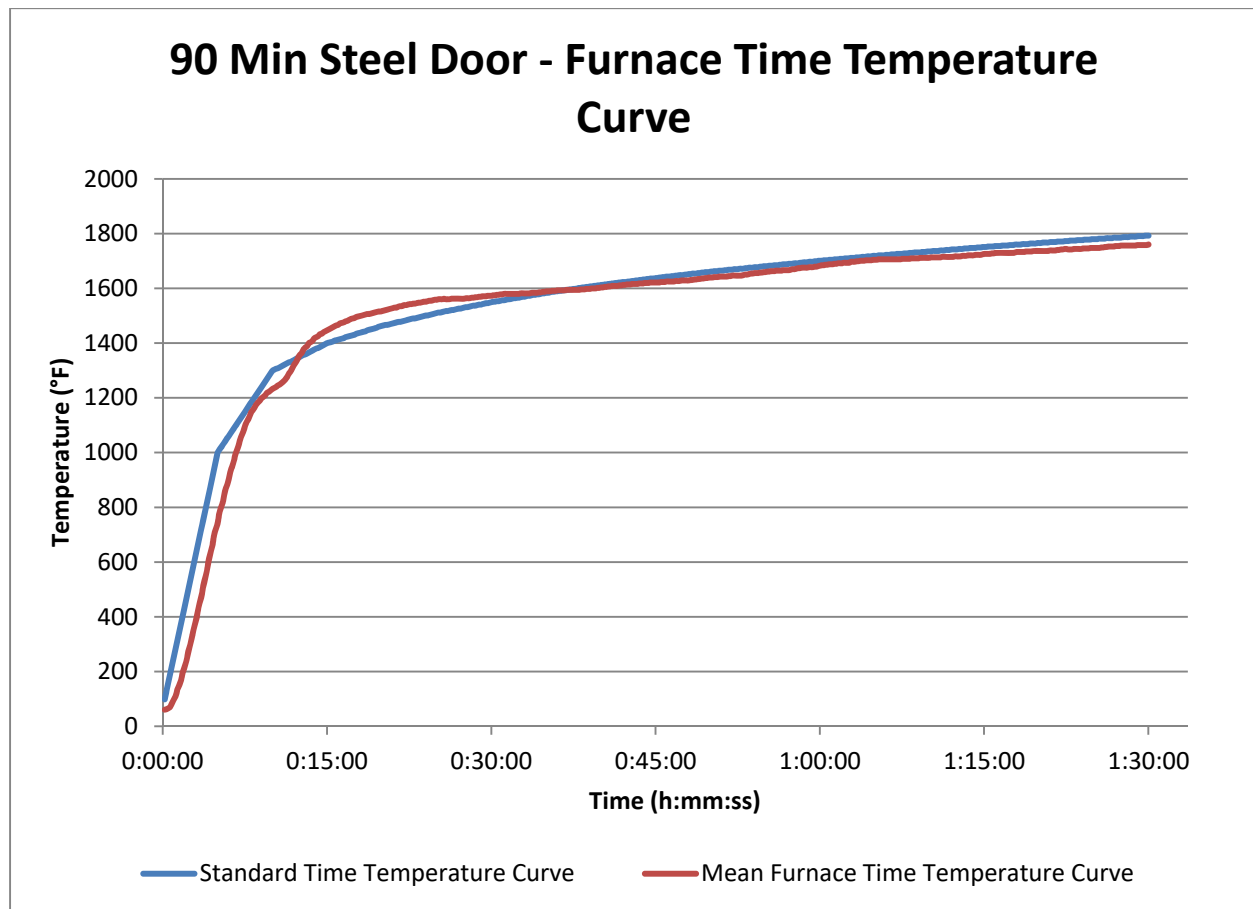
**Figure 3: Furnace Time Temperature Curve.**

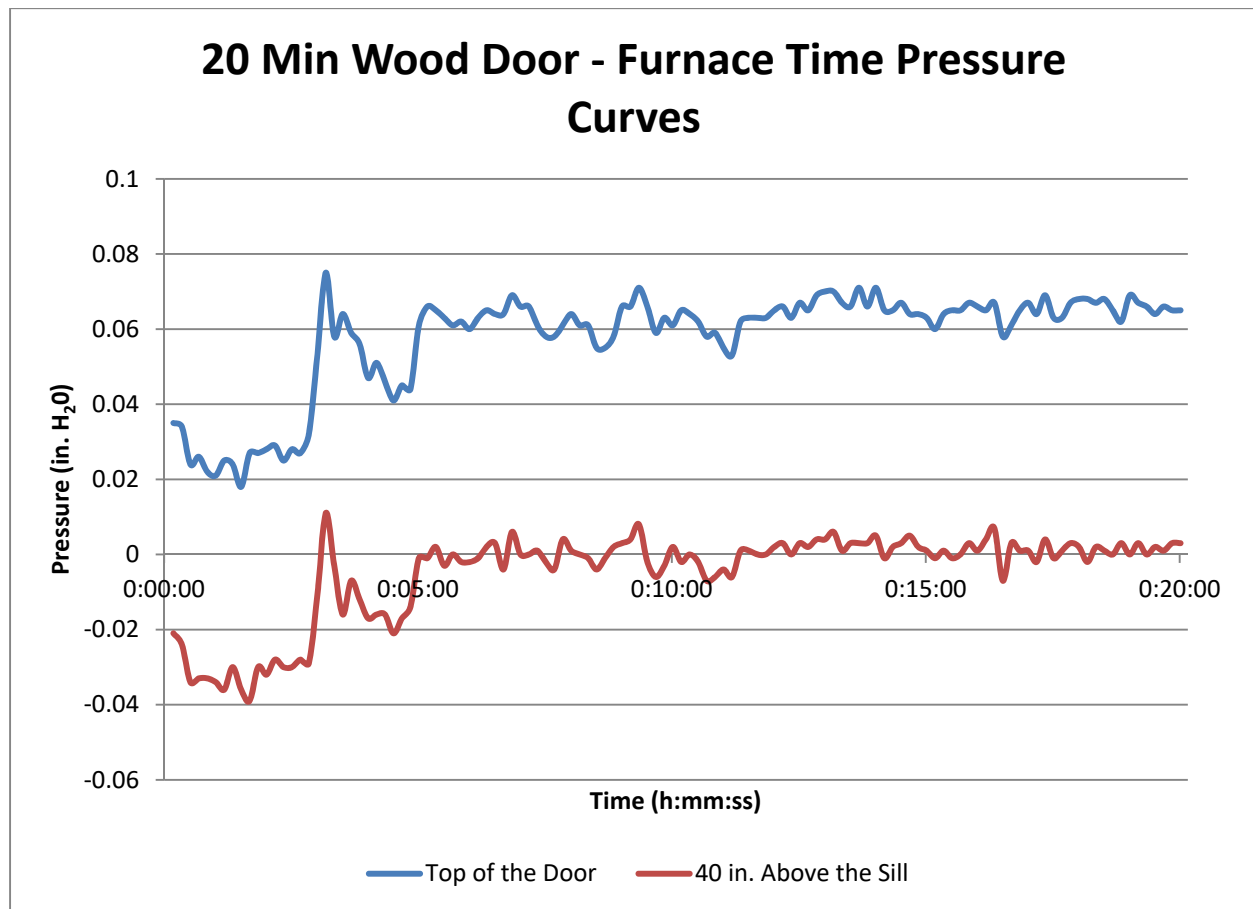
**Figure 4:** Furnace Time Pressure Curve.

The pressure was continuously monitored using calibrated pressure transducers. After the first 5 minutes of the test the pressure 40 in. from the sill was set to zero for the remainder of the test.

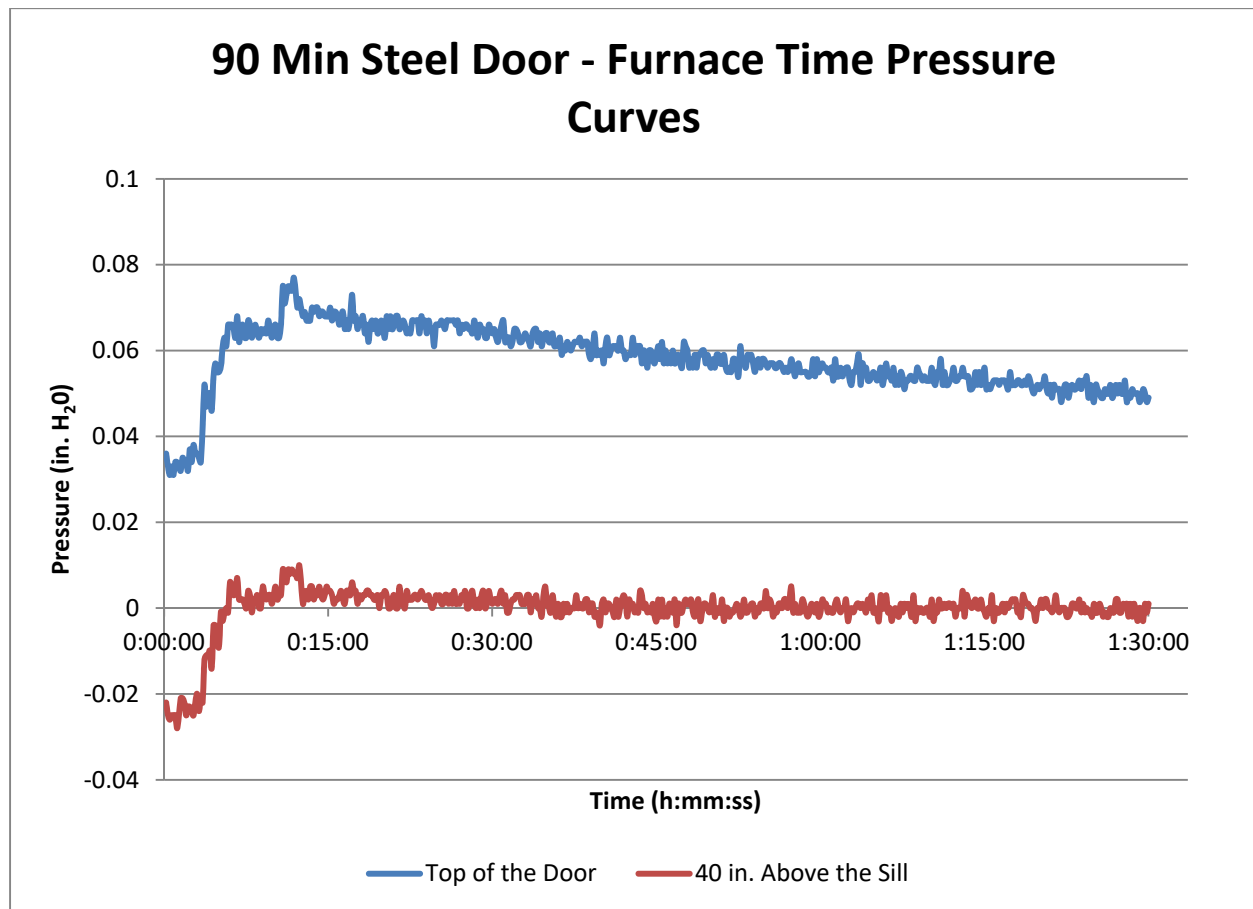
**Figure 5:** Furnace Time Pressure Curve.

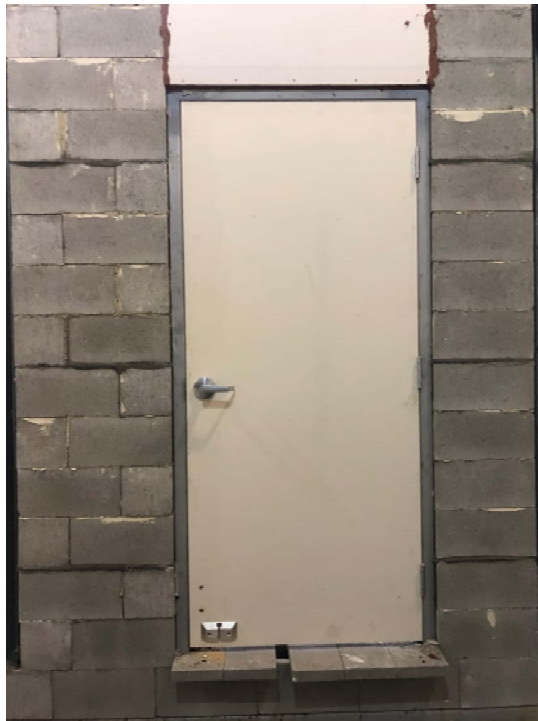
**Figure 6:** The exposed face of the wood door test assembly prior to the fire test.

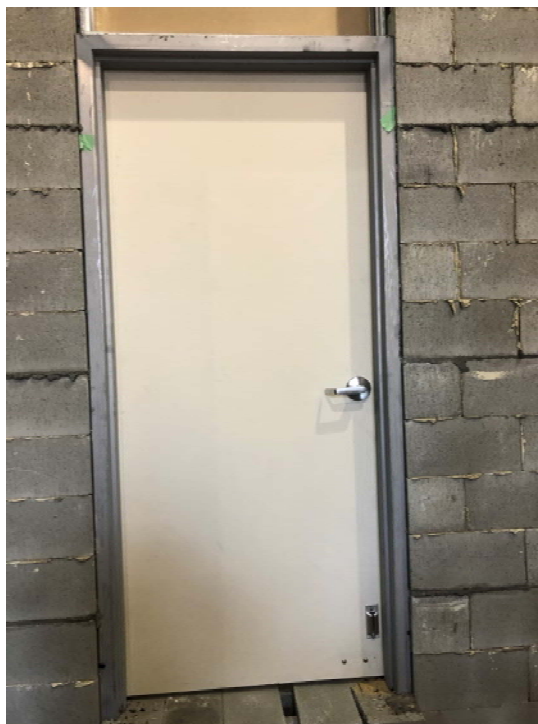
**Figure 7:** The unexposed face of the wood door test assembly prior to the fire test.

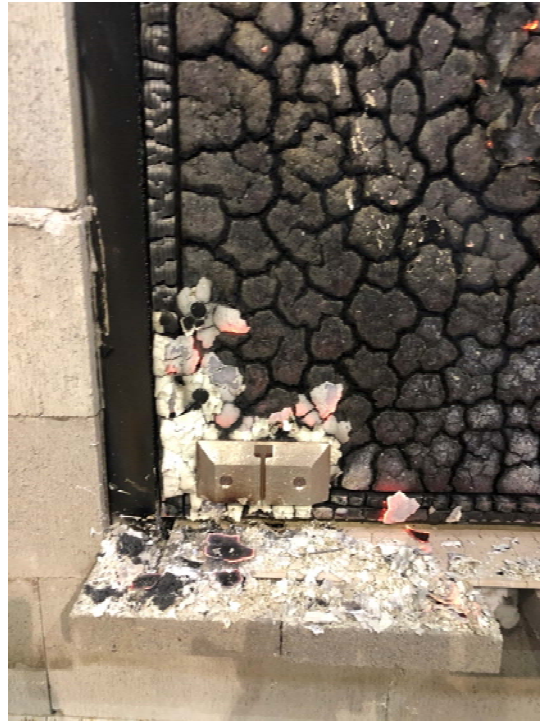
**Figure 8:** The exposed side of the NightLock after the fire test.

There was no flaming at or around the Taylor Brother Door Lock NightLock Lockdown hardware for the duration of the tests.

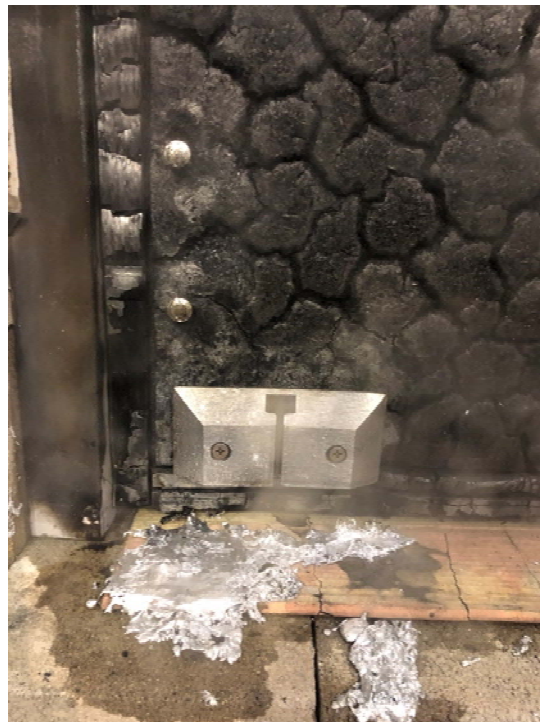
**Figure 9:** The exposed side of the NightLock after the hose stream test.

Immediately after the fire tests, a hose stream test was conducted for 14 seconds after the wood door test and 36 seconds after the steel door test. The NightLock Lockdown hardware successfully met the conditions of acceptance for the hose stream test: no through openings were developed that would allow a projection of water from the stream beyond the unexposed face during the time of the hose stream test.

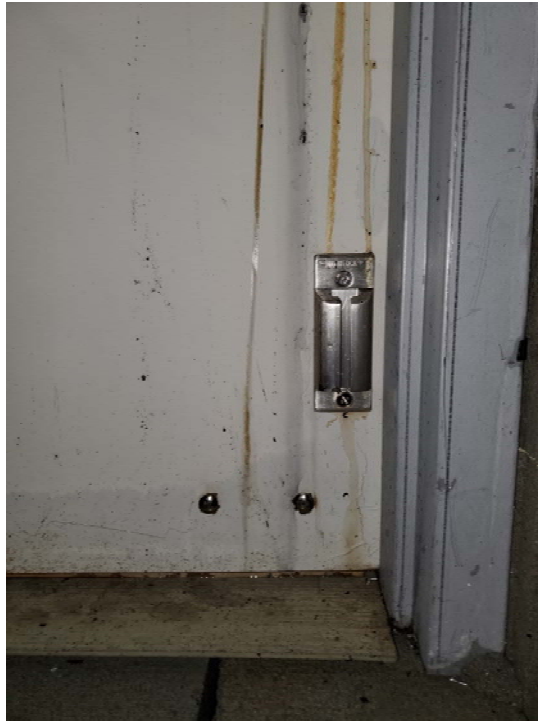
**Figure 10:** The unexposed face of the wood door test assembly after the hose stream test.

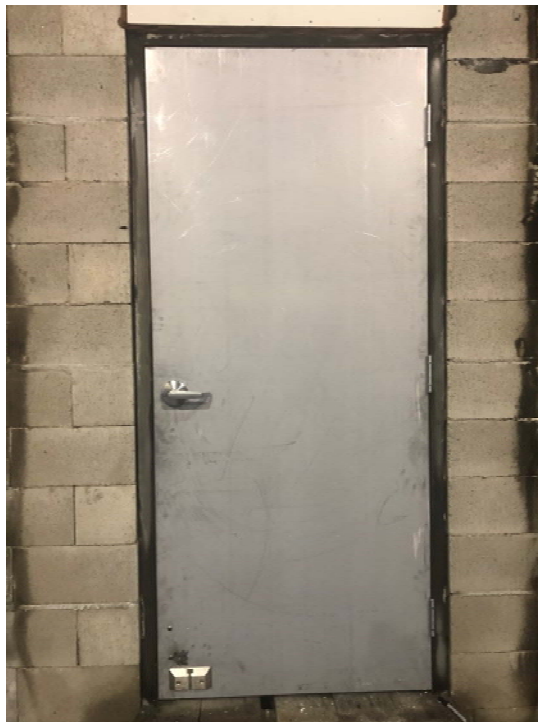
**Figure 11:** The exposed face of the steel door test assembly prior to the fire test.

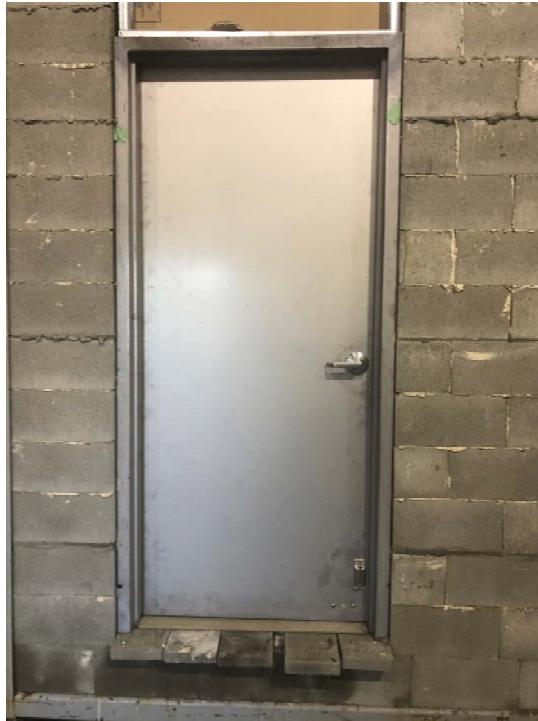
**Figure 7:** The unexposed face of the steel door test assembly prior to the fire test.

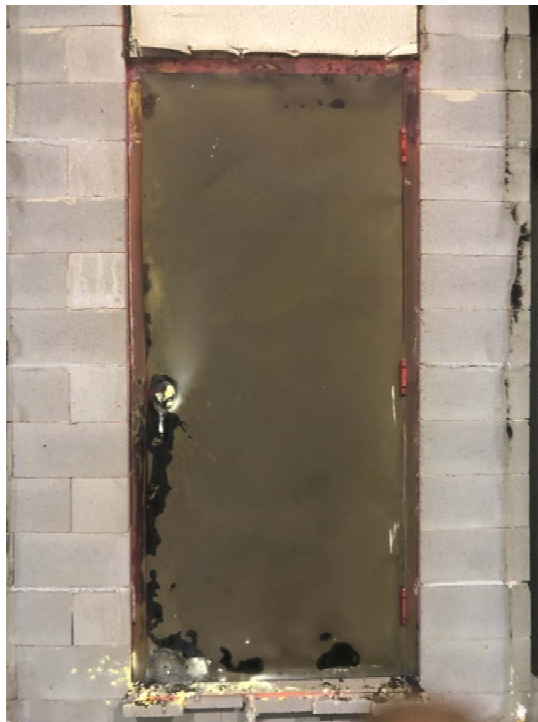
**Figure 8:** The exposed side of the steel door assembly after the fire test.

Test Time (min)	Unexposed	Exposed
2:30	The door is bowing into the furnace.	
4:00	Venting from the hardware.	
5:25	Venting from the latch.	
7:00		Flaming at the latch.
14:20	Door skin is deforming.	
17:00	Bottom latch side is discolouring.	
20:00	The latch handle is dropping.	
30:00		The floor device is no longer visible.
90:00	Test discontinued.

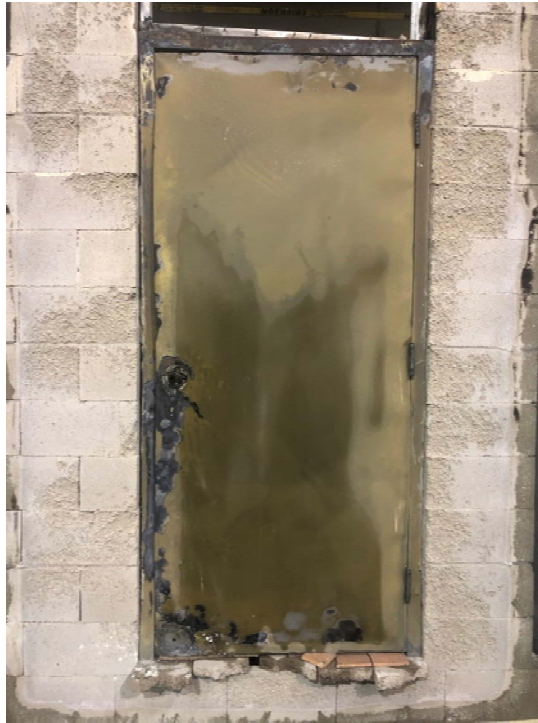
**Figure 9:** The exposed side of the steel door test assembly after the hose stream test.

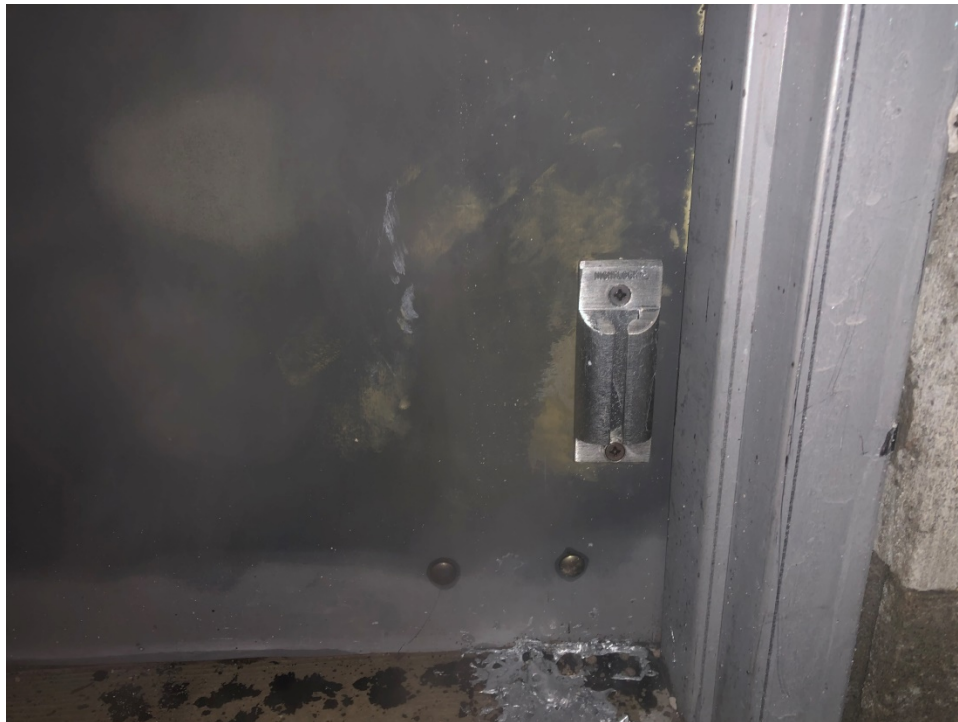
**Figure 9:** The unexposed side of the NightLock after the hose stream test.

The doors did not experience flaming on the unexposed face of the doors and no through openings formed at or near the NightLock Lockdown devices during the fire tests or the hose stream tests. The NightLock Lockdown device met the requirements of UL 10c and ULC S104 for a 20 minute and 90 minute fire-resistance rating with hose stream.
